# Case Study #18 Cowley International College

Following on from the service and maintenance contract carried out during April and May of this year, RainCatcher's site team were engaged to carry out the tank repair as identified at the initial tank clean service earlier in 2015.

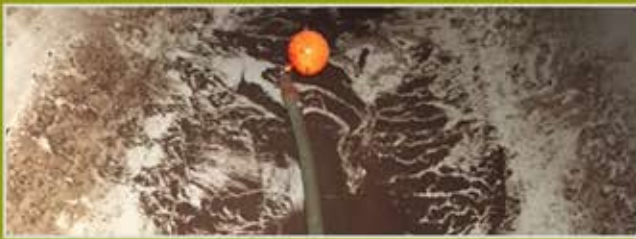
Before any work could begin, chlorination of the stored water had to be tested. Once it was determined the levels were satisfactory the tank could be emptied. As shown, a considerable amount of dirt and sediment was found in the tank due to backfill ingress; this had to be cleared before the actual tank repair could begin.

*Left: a small section of the sediment found at the bottom of the rainwater tank.*

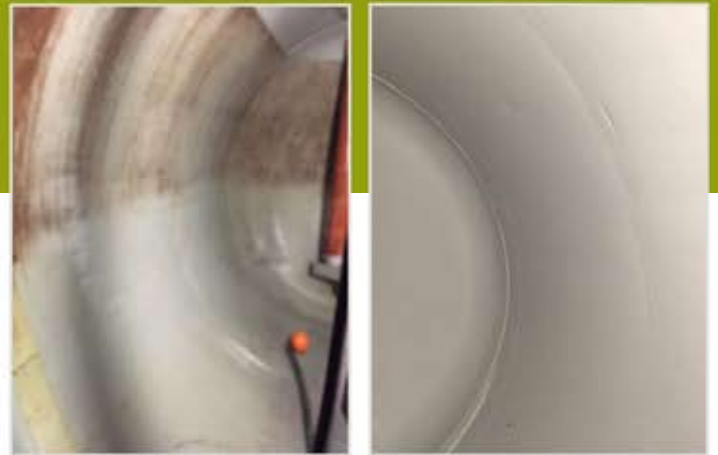
*Before (below left) and after (right) the tank clean.*

After cleaning and drying the tank was complete, removal of the original failed repair (previously carried out by others) began. This enabled the operatives to seal and fix weakened and compromised sections of the tank, preventing ingress of backfill material and debris.

This was achieved with a resin based bonding paste and slow cure catalyst, applied to all edges, joints and crevices. Matting and tissue were used to ensure a smooth finish before a resin wash was brushed over the entirety of the tank, followed by a gel coat. Finally, an air mover of 110 volts was utilised to force fresh air into the tank for six consecutive hours. This now carries a full RainCatcher guarantee.

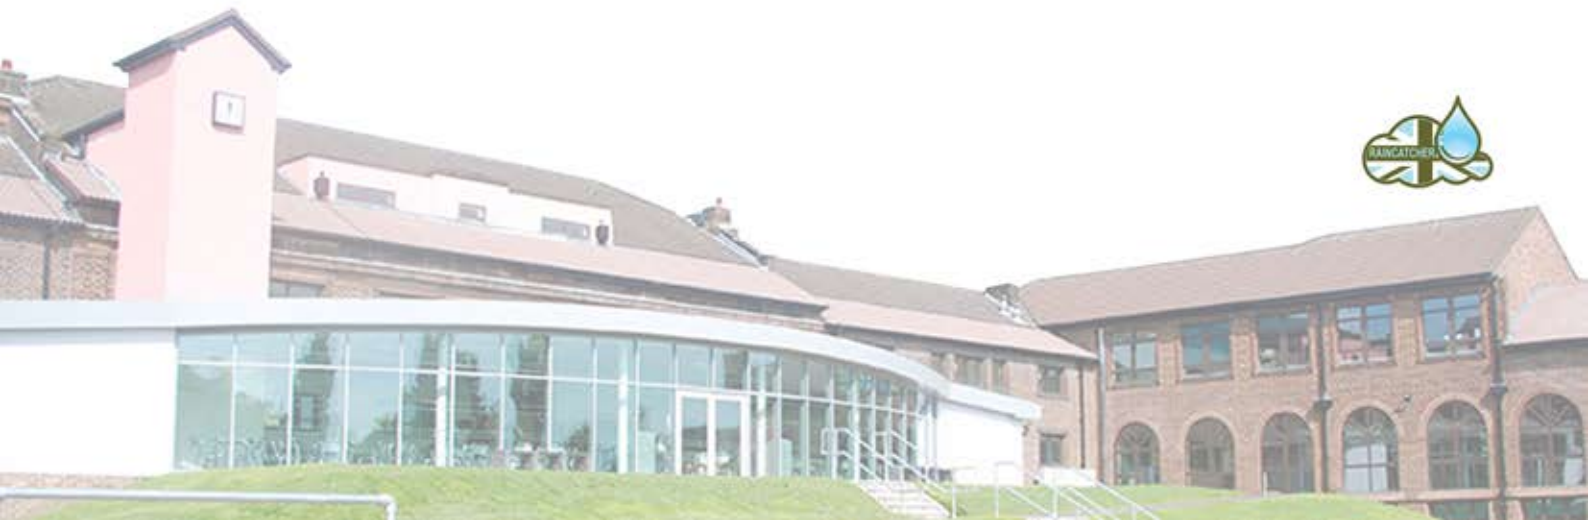
The contract was complete in just three days, following high health and safety measures including Confined Spaces Regulations. This resulted in a successfully repaired rainwater harvesting tank and fully functional rainwater harvesting system in accordance with BS 8515.
